Solution for the conclusion of the Mackenzie access in Sao Paulo Line 4 Subway.

ABSTRACT: The Mackenzie access of Higienópolis Station, of the Sao Paulo Line 4 subway consists of two siccative shafts, one of them was built several years ago and the construction of the second one began in 2012. When 31 m of the second shaft were excavated, it was a soil piping phenomena in the bottom of the shaft. To complete the construction of the Mackenzie Shaft the monitoring data was analyzed by a back analysis to set up the properties of the grown which matched well with the monitoring data. After this, the feasibility of completing the excavation with the protection of jet-grouting piles was verified. The calculations carried out showed that the safety factor was 1.4. In late 2013 it was proceeded to remove the ground stacked in the bottom of the shaft; prior activity to complete the excavation, which was planned in seven sectors. During the excavation of sectors 2, 5 and 7 some problems appeared which were resolved by a punctual drainage. The excavation ended June 24th, 2013.

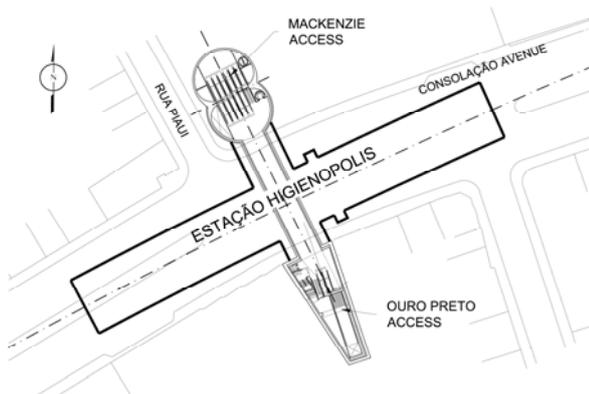
The Station of Higienópolis of the Sao Paulo Line 4 subway has two accesses: Mackenzie and Ouro Preto, as shown in Figure 1.

Figure 1. Higienópolis Station and its accesses.

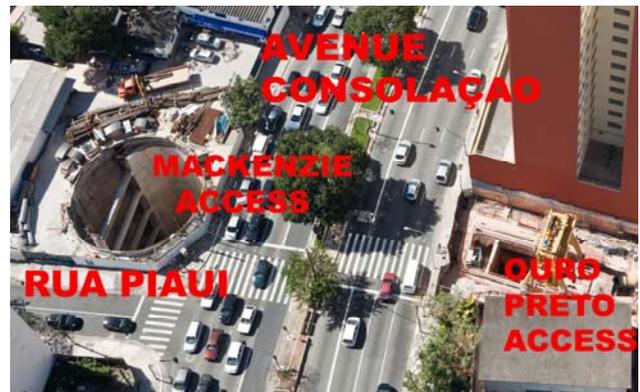
The Mackenzie access is formed by two siccative shafts, with a diameter of 20 m each one. The nearest shaft to the Consolação Avenue was built several years ago, as shown in Picture 1; but the construction of the second shaft, which should have 32 m deep, started in

Picture 1. First shaft built in Mackenzie access.

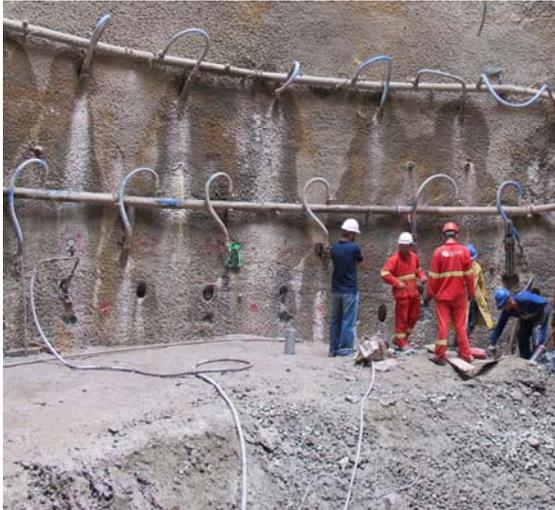
The excavation progressed without difficulties until the depth of 24 m was reached, when it was considered necessary in order to improve the efficiency of the recess of the water table to develop a system of local drains, supported by a vacuum system, as shown in Picture 2.

Picture 2. Drainage pipes with vacuum system.

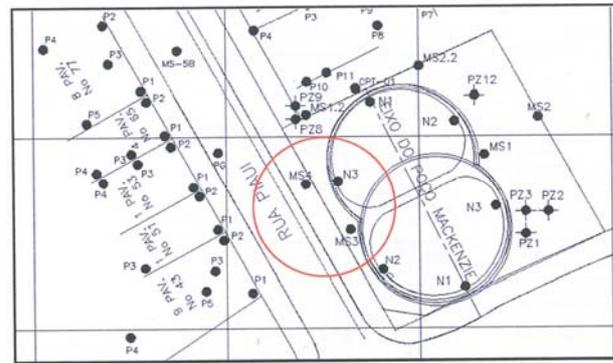
It was carried out a detailed analysis of the measurements available from the instrumentation placed for monitoring the construction of the Mackenzie Shaft, whose implementation is shown in Figure 2.

Figure 2. Monitoring for the construction of the Mackenzie shaft.

The monitoring elements are constituted by piezometers (PZ), exterior survey control points (P and MS) and optical measurement points of convergences in the Shaft (N).

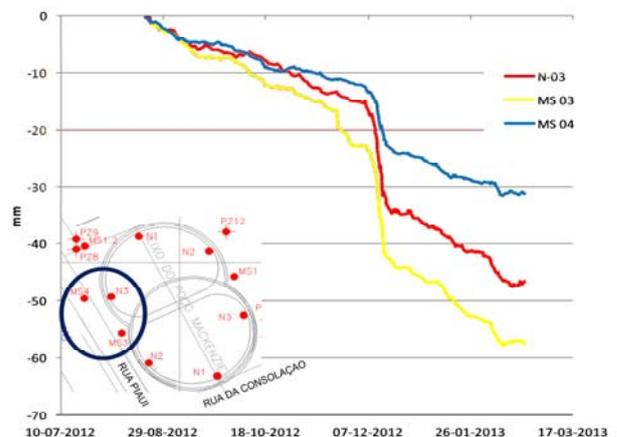
Figure 3 shows the evolution of the vertical movements in these three monitoring points and, as it can be seen, after the major changes occurred during the fluidization of December 8th, 2012, the reference points were still descending.

Figure 3 also clearly shows that the greatest movement occurred in the point MS-3, which is the closest to the vertical in the area where the soil piping occurred.

Figure 3. Evolution of the monitoring points N3 MS-3 and MS-4.

In order to specify the conditions of the soil piping occurred in the shaft, on December 8th 2012, a "back analysis" of which aim was to reproduce the vertical movements of the monitoring points MS-3 and MS-4, represented in figure 3, was done with the following construction process:

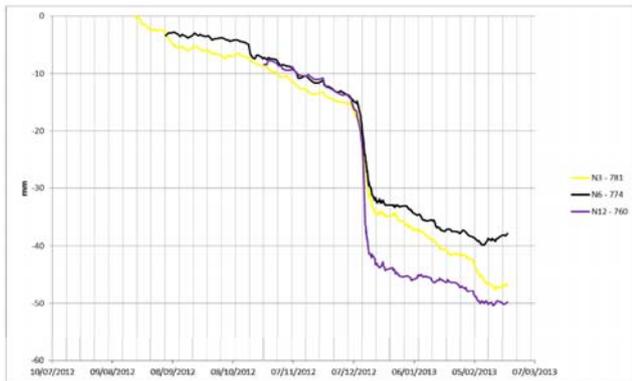
Figure 4 shows the evolution of the vertical movements in three points situated inside the shaft: surface (N1), at a depth of 7 m (N6) and at a depth of 21 m (N12)

Figure 4. Evolution of the verticals movements of the reference points N1, N6 and N12.

From Figure 4 three important points are concluded:

I.- Until the soil piping in the bottom of the shaft, on December 8th 2012, the support of the shaft sank evenly.

II.- During the soil piping process point N12 sank up to 42 mm, while the points N1 and N6 sank up to 33 mm.

III.- After the soil piping three reference points have continued sinking, with a similar rate as before the fluidization.

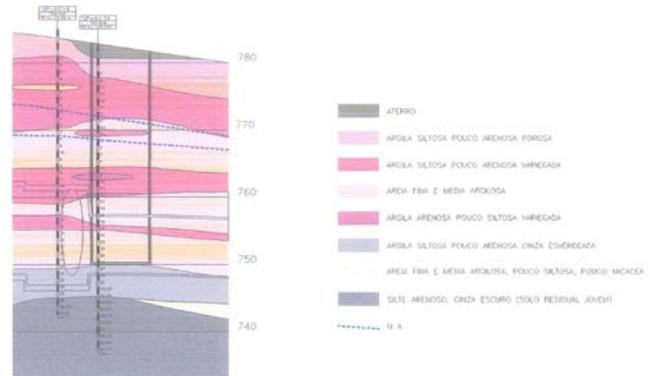
The ground on which the excavation Mackenzie Shaft was carried out is constituted by an alternation of clays and sands, until the bottom

of the excavation where the ground is a sandy silt, as shown in Figure 5

Figure 5. Shaft Mackenzie Stratigraphy.

The beginning of the Mackenzie Shaft is at level 781 and the bottom of the excavation at level 749, while the original water table varies between the levels 766 and 768.

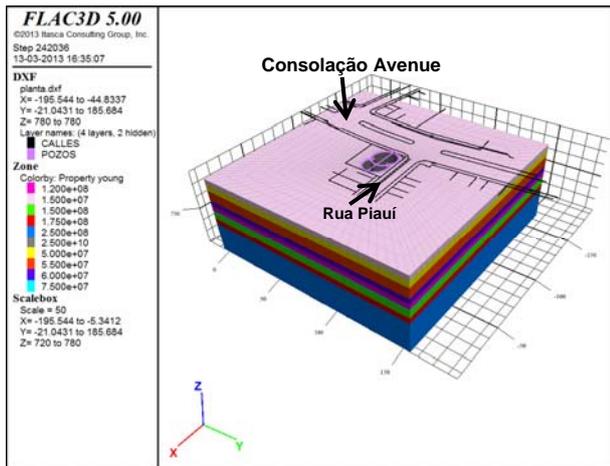
To carry out the "back analysis" a 3D model was performed, as shown in Figure 6, which has a length and width of 170m and 60m height.

Figure 6. Geomechanical Model.

In this model, the Z axis corresponds to the direction of gravity, the x-axis to the direction of Piauí Street and the Y axis to the direction of the Consolação Avenue.

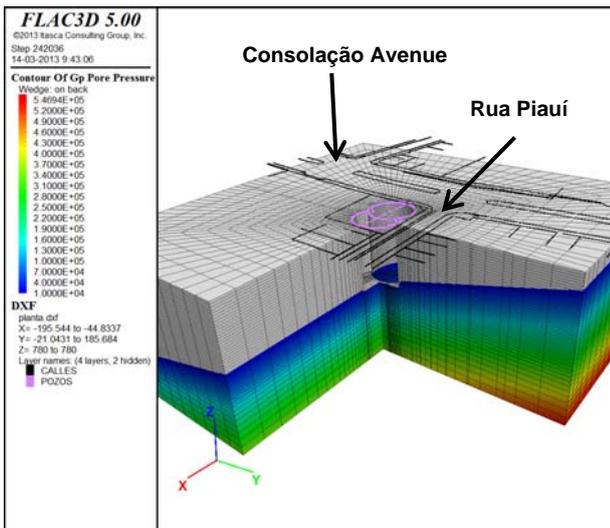
Figure 7 shows the distribution the water table in the model.

Figure 7. Position of the water table in the model.

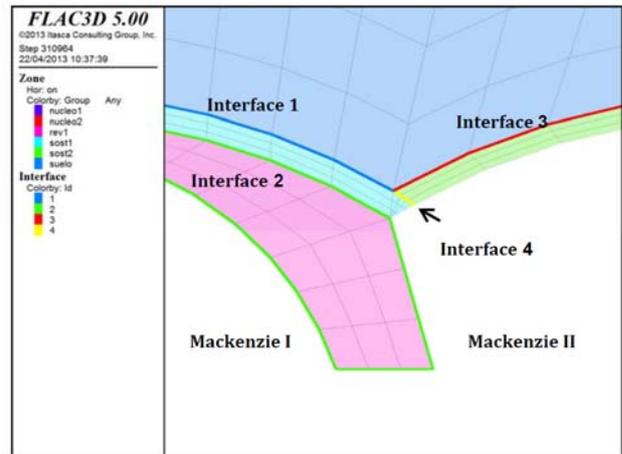
One of the most important aspects of this model is the simulation of the junction between the primary lining Mackenzie I and II Shafts, for which we considered the four interfaces shown in Figure 8.

Figure 8. Interfaces to simulate contact between the linings of the shafts.

These four interfaces control numerically the following connections:

Interface 1. Contact between the Primary lining and the ground in the Mackenzie I shaft. The strength of this interface has been characterized by $2/3$ of the shear strength of the ground with which it is in contact (reduction of cohesion and friction angle).

Interface 2. Contact between the Primary and the Secondary Lining of Mackenzie I Shaft, materialized through a waterproofing layer, characterized by $\phi = 20$ and $C = 0$.

Interface 3. Contact between the Primary lining and the ground in the Mackenzie II Shaft. This interface has been characterized as Interface 1.

Interface 4. Contact between the Primary lining Mackenzie I shaft and Mackenzie II shaft. This interface is characterized by a null cohesion and a friction of 32° .

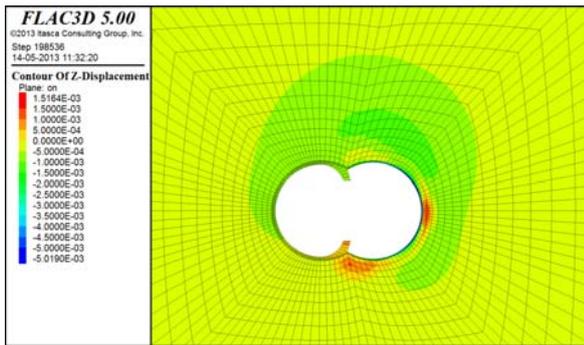
Figure 9 shows the distribution of the subsidence on the surface of the model, once it has reached the equilibrium after excavating the Mackenzie II shaft up to 750 level.

Figure 9. Subsidence at the surface, if the interface 4 works due to friction along the entire length of the shaft.

This distribution of movements was obtained assuming the hypothesis that the junction between the primary linings of the Mackenzie I and II shafts worked properly along the entire length of the shaft.

Based on the information contained in Figure 9, the following conclusions were obtained:

I.- The maximum subsidence calculated is between 1 and 5 mm; values below 60 mm that were measured at the point MS-3.

II.- The space distribution of the subsidence does not match the actual measurements obtained during the construction, since the calculated maximum movements are on both sides of the axis of the two shafts and, in the construction they are concentrated closer to Rua Piauí.

These strong divergences between the calculations and the real movements indicated that the hypothesis that the Interface 4 worked properly across the shaft's length is incorrect.

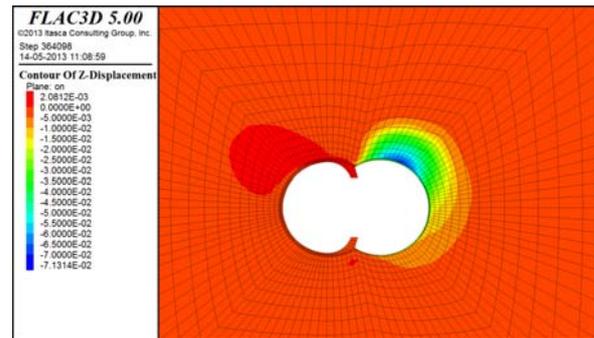
Therefore new cases were calculated assuming that the length in which the Interface 4 worked properly was decreasing and it was found that when the Interface 4 was working in depths between 26 m and 32 m is when the results of the calculations fit in better with the real situation, as shown in Figure 10.

This figure shows that the maximum vertical movements of the ground are concentrated between the Mackenzie shaft and the Piauí Street, just as it happened in reality.

Moreover, the vertical movements calculated for the position of the monitoring points MS-3 and MS-4 are between 60 and 70 mm, range in which are included the measurements made in points MS-3 and MS-4.

Figure 10. Distribution of subsidence if the junction between the primary linings of the two shafts works properly at a depth between 26 and 32 m.

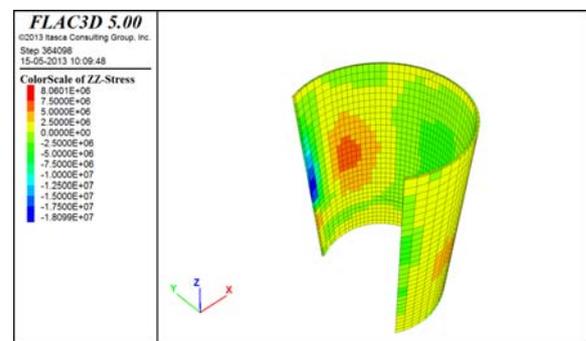
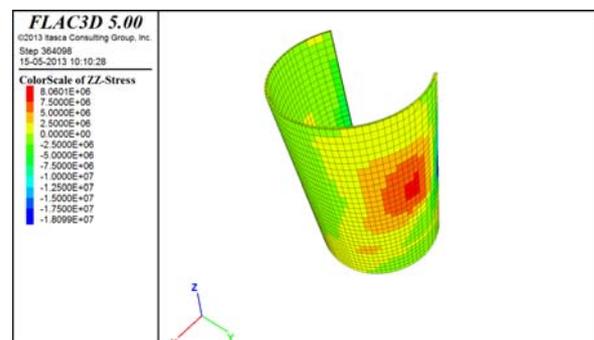
From the calculations done with the assumption that the joint between the two primary supports worked partially, the distributions of the stress induced in the two faces of the support have been obtained, as shown in Figure 11.

I. Inner side of the support.

II. External surface of the support.

Figure 11. Stress distribution of σ_z in the shaft support structure (Positive values are tractions).

This figure shows that in the support structure has created a tensile area, with a maximum value of about 8MPa, which is a high value and probably would have produced a horizontal tensile crack.

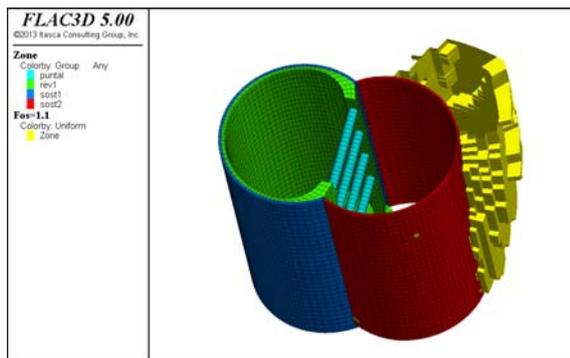
Calculations done have established that the safety factor (SF) when the excavation reached the 750 level was 1.1, which justifies the occurrence of the soil piping of December 8th 2012. The SF has been determined according to the criteria of Duncan (1996).

Figure 12 shows the elements of the model around the shaft in which SF=1.1, which would be the ones to be mobilized during the soil piping. It can be seen that most of these elements are located between the Mackenzie Shaft and Piauí Street.

Figure 12. Elements with SF = 1.1 to reach the excavation at a level of 750.

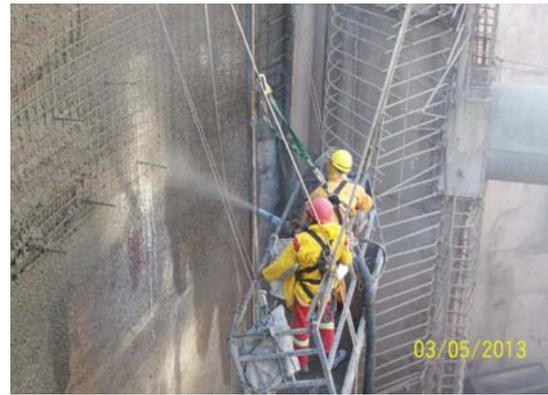
Picture 3 shows a view of the execution of one of the reinforcement rings and Picture 4 shows the reinforcement ring at the bottom of the excavation.

Picture 3. Reinforcement of the primary linings between levels 780 and 777.

I.- Reinforcement of the primary lining of the shaft with three rings of shotcrete of 3 m high, to prevent the effect of induced tensiles of the produced movements.

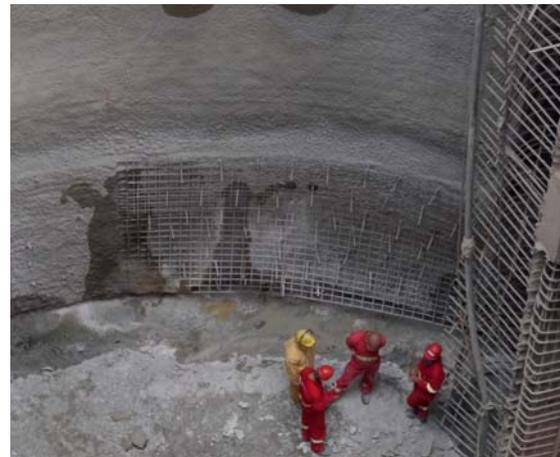
Picture 4. Reinforcement of the primary linings between levels 755 and 758.

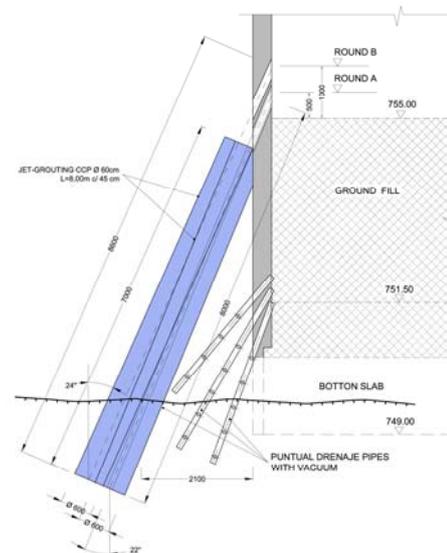
The construction of a conical wall of jet grouting piles was designed, drilled from inside of the shaft to the level 755, as shown in Figure 13.

Figure 13. Wall of jet-grouting piles.

II.- Construction of a conical wall of jet-grouting piles to prevent the movement of the shaft's structure and isolate the bottom of the excavation from the effect of water pressure.

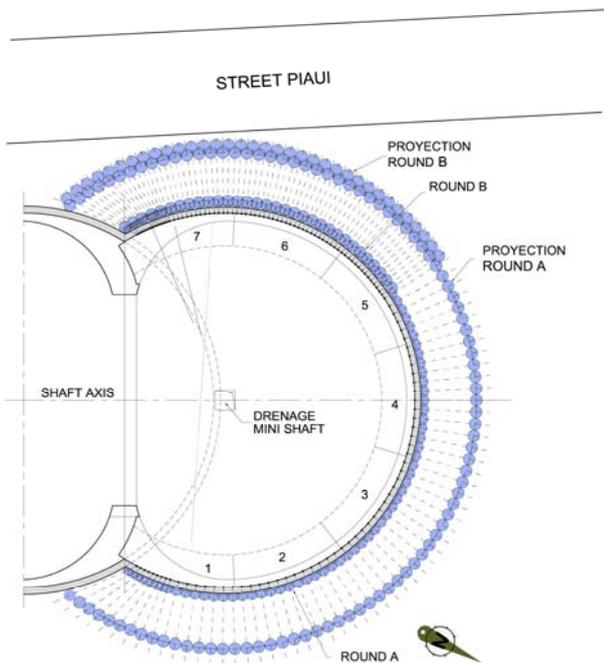
The jet-grouting piles are around the entire of Mackenzie II shaft, although in the nearness of Piauí Street two rows of piles were established, as shown in Figure 14.

Figure 14. Disposition in plan view of the jet-grouting piles.

After completing the removal of ground it was proceeded to continue the excavation, for which the bottom of the shaft was divided into 7 sectors, as shown in Figure 14.

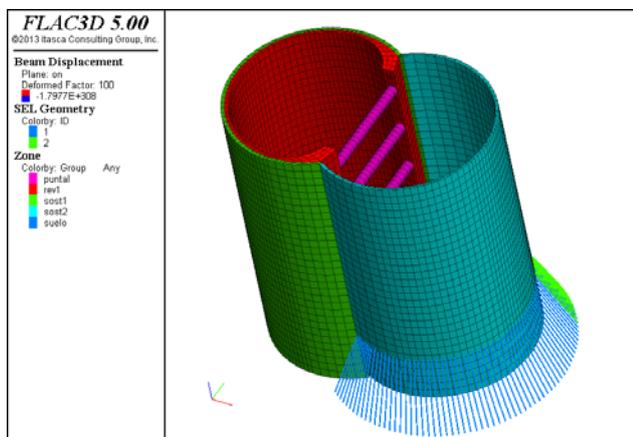
To verify the proposed solution the 3D model employed in the back analysis was modified by adding jet-grouting piles, as shown in Figures 15 and 16.

Figure 15. 3D model with jet-grouting piles.

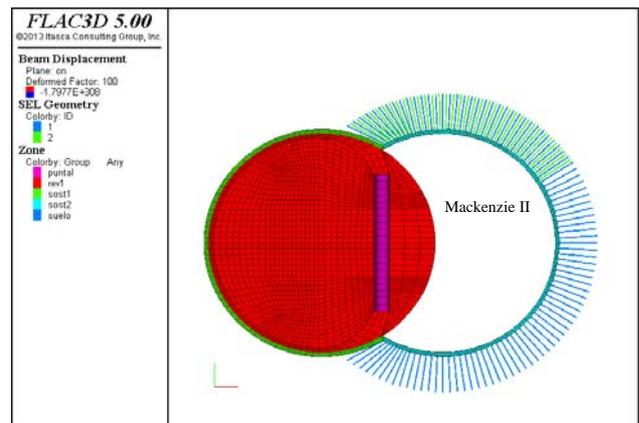
Figure 16. Modeling in plan view of the jet-grouting.

This model was solved with the software FLAC 3D simulating the stacked lands removal in the shaft, between levels 755 and 750 and the excavation of the meter of ground missing to reach the bottom of excavation, at level 749.

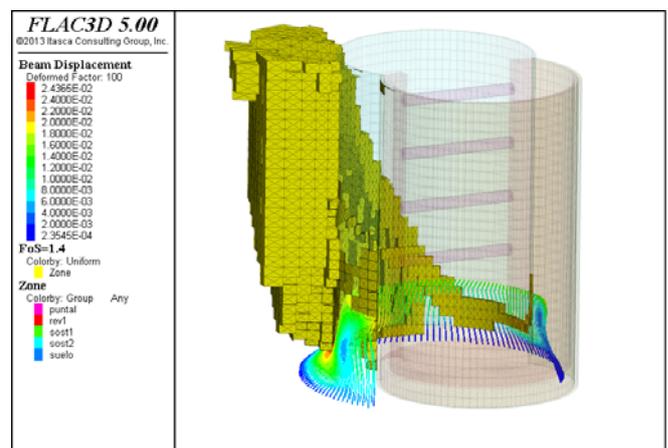
Figure 17 shows the deformation of the jet-grouting piles at the end of the excavation and also represents the grounds having a SF = 1.4, which is the same calculated for this solution, which was considered satisfactory.

Figure 17. Deformation of the jet-grouting piles and grounds with SF = 1.4.

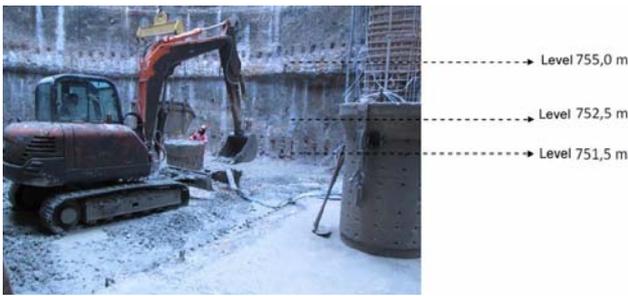
Picture 5 shows a view of the removal process of ground and Picture 6 shows the bottom of the shaft completely clean, June 20th 2013.

Picture 5. Removal of ground at the bottom of the shaft.

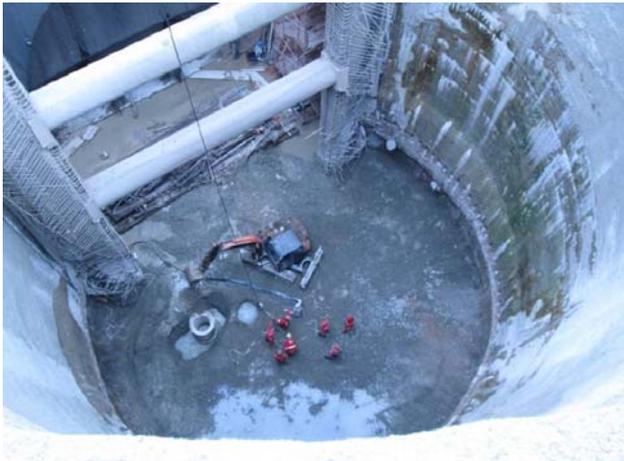
Picture 6. Bottom of the shaft 20/06/2012 at level 750.

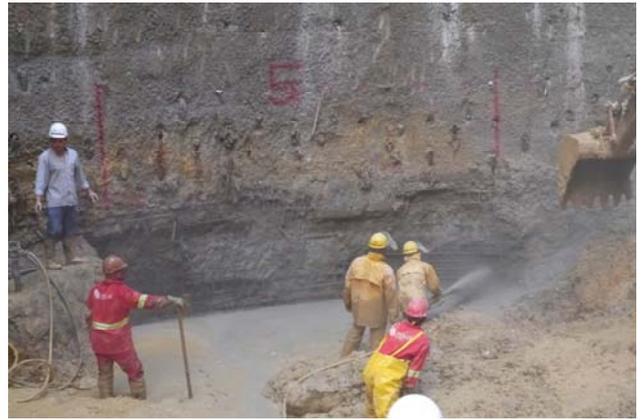
During the excavation of sectors 2, 5 and 7 water inflows occurred, with a caudal close to 5 l/s. Although this rate was not very important, the clayey nature of the ground towards the bottom of the shaft was full of mud. This problem was controlled with a system with vacuum drainage pipes and a permanent drainage at the bottom.

Picture 7 shows a snapshot of the shotcrete after ending the excavation in Sector 5, which was one of the most controversial.

Picture 7. Shotcrete projected in Sector 5.

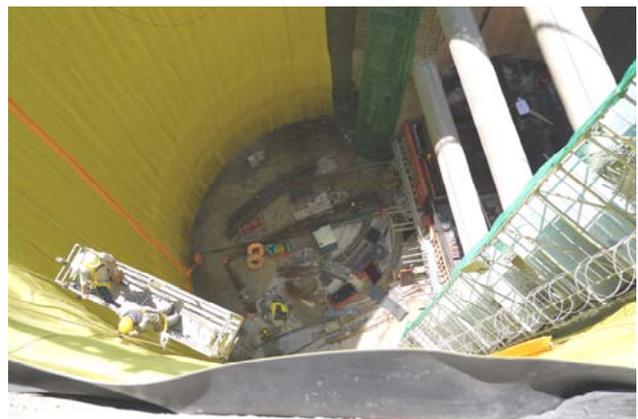
Picture 8 shows a view of the bottom of the shaft during the phase of waterproofing, after the construction of the slab concrete bottom.

Picture 8. Waterproofing Mackenzie shaft, after finishing the primary lining.
